**COMP-ECO**

### D1.1 Technical report on research activities and demonstrator

<b>LEAD BENEFICIARY:</b>	AFIT
<b>AUTHOR(S):</b>	Michał Dziendzikowski, Krzysztof Dragan (AFIT)
<b>CONTRIBUTOR(S):</b>	Anna Boczkowska, Kamil Dydek, Paulina Latko-Durałek (WUT), Rafał Kozera, Paweł Duralek (TPF), Otto Bergsma, Nan Tao, Roger Groves (DELFT), Georgios Tzortzinis, Evgenia Madia (DRESDEN)
<b>DATE OF ISSUE:</b>	28.11.2025
<b>DISSEMINATION LEVEL:</b>	PU

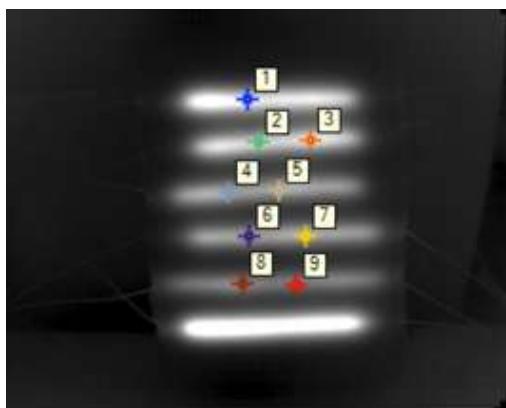
Sample: 6 heaters, place: between 2<sup>nd</sup> and 3<sup>rd</sup> layer, after impact

The CNT-doped strips developed as part of TASK2 can be effectively used in active thermography as an internal heat source. In addition, they allow the identification of damage (delamination) through visible brighter spots that occur along the length of the strip and are associated with differences in heat dissipation in the material.

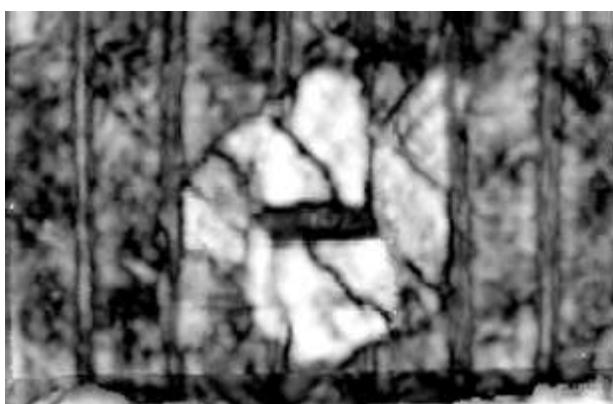
Sample: 6 heaters, place: between 2<sup>nd</sup> and 3<sup>rd</sup> layer, after impact

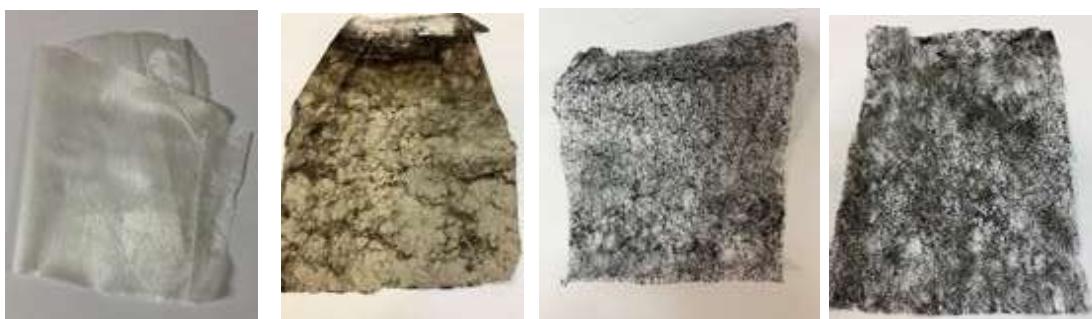
Figure 10. From the left: neat coPA veil before metallization; coPA veil after metallization; PPS veil with 1wt% CNT before metallization; PPS veil with 1wt% CNT after metallization.

Figure 1 shows the veils before and after the metallization process. The whole process for both veils went well, and a nickel-phosphorus layer was created on the macroscale. It was visible, especially for the neat coPA veil, which was white before metallization and grey after (Figure 1 a and b) . A good point is that veils were not dissolved in the used solvents. However, the main problem was that veils easily moved during step no7, causing deformation, especially for the coPA veil.

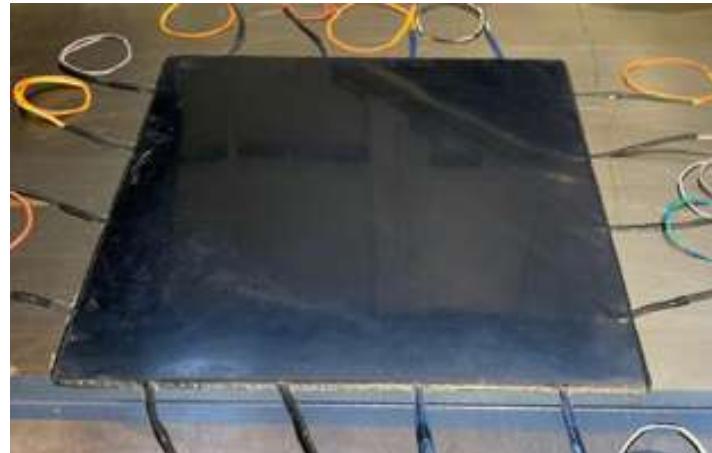
Figure 36 Specimen with embedded PZT sensors after curing

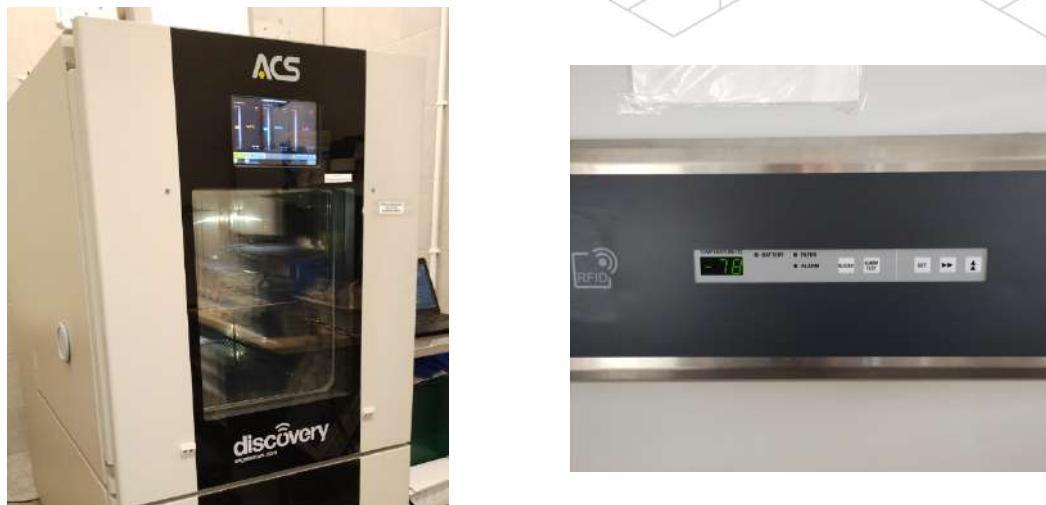
Figure 41: Chambers used for environmental tests

- exposure to elevated temperature (70C) and high humidity (80%) for extended period of time (6 weeks) as well as to very low temperatures (below -70C).

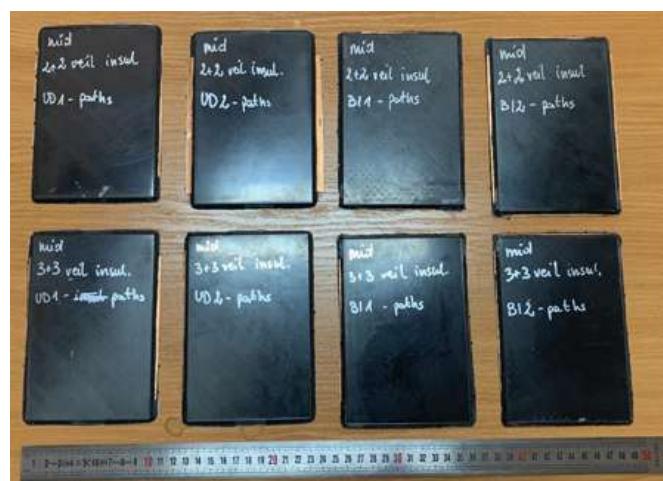
Figure 49. CFRP system with conductive grids

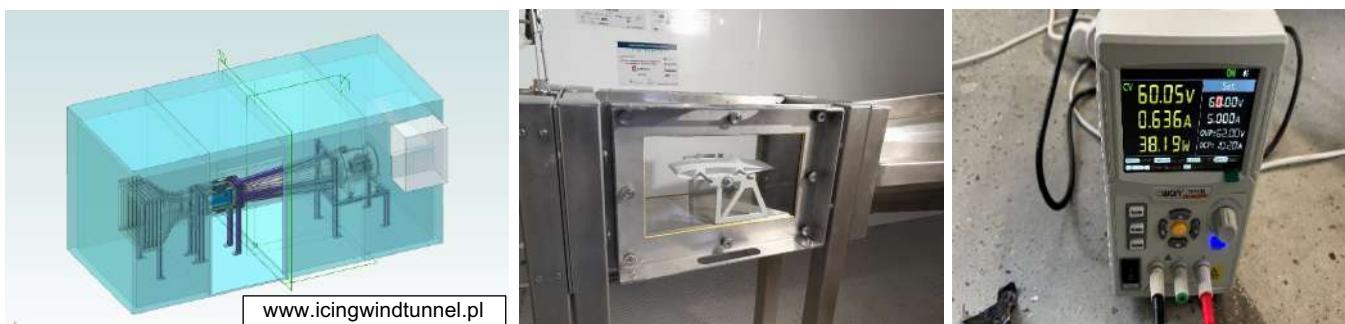
Figure 56: Icing wind tunnel set up and tests parameters of power supply
